## DDI IMAGERY ANALYSIS STAFF

NAME Chu Le Hwy. Bridge SE No. 1 over Song Tien <input type="text"/> Bridge No. 28 on NE 48-7	COUNTRY North Vietnam	COORDINATES 18 10N - 105 43E WF761102	25X1
MAP JOG (A) 1501 NE 48-7		BRIEF NO: PIB 75500 February 1967	25X1

25X1	NAME	Ban Houei Cui Hwy. Bridge	COUNTRY	North Vietnam	COORDINATES	19 19N - 104 20E VG298357
		over stream [redacted] Bridge No. 7 on NE 48-2				
25X1					BRIEF NO:	
	MAP				JOG (A) 1501 NE 48-2	
LOCATION:						1 nm NW of Ban Houei Cui on Route 7.

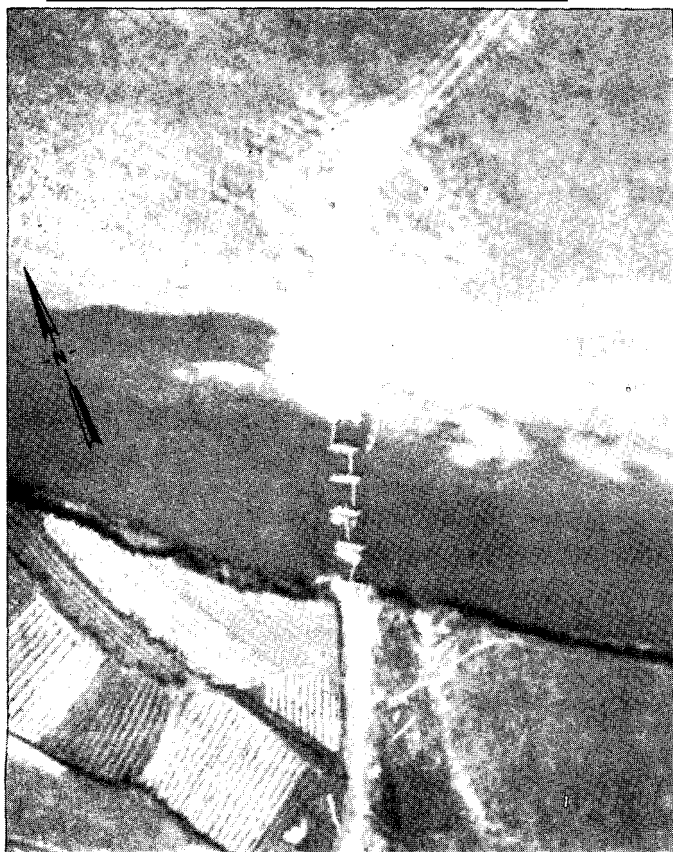
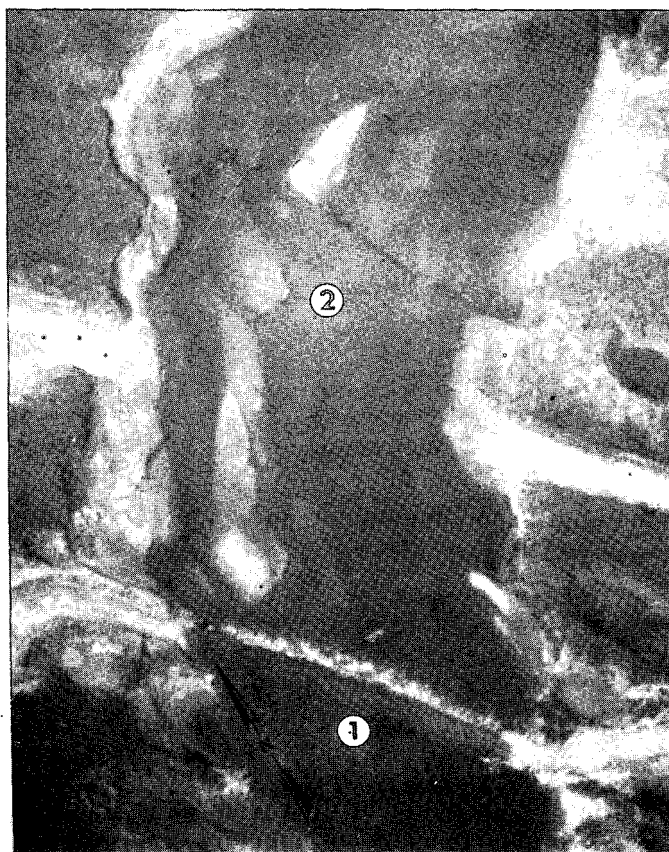
All piers have been reconstructed.

- By-Pass No. 1 - constructed 250' x 20' (approx.) ford; probable rock/gravel base; 1830' N of main bridge; serviceable.  
By-Pass No. 2 - constructed 280' x 20' (approx.) ford; probable rock/gravel base; 1890' N of main bridge; serviceable but not in use.

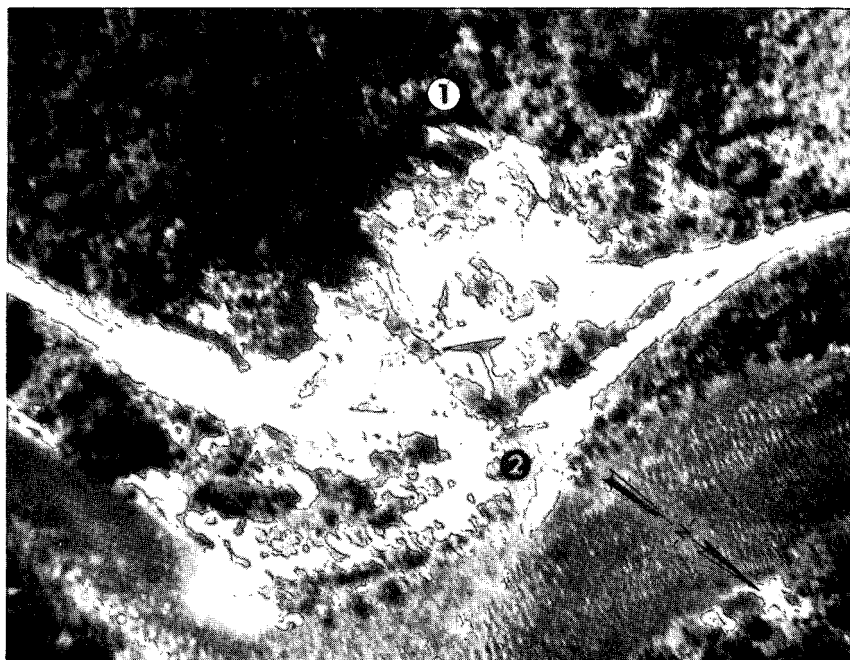
One 10' span and the 50' span dropped; one 10' span moderately damaged.

By-Pass No. 1 - single span (probable) [redacted] (approx.) wood deck-type bridge; 100' SW of main bridge; undamaged - serviceable.

25X1 By-Pass No. 2 - constructed [redacted] ford; probable rock/gravel base, 35' NE of main bridge; serviceable.

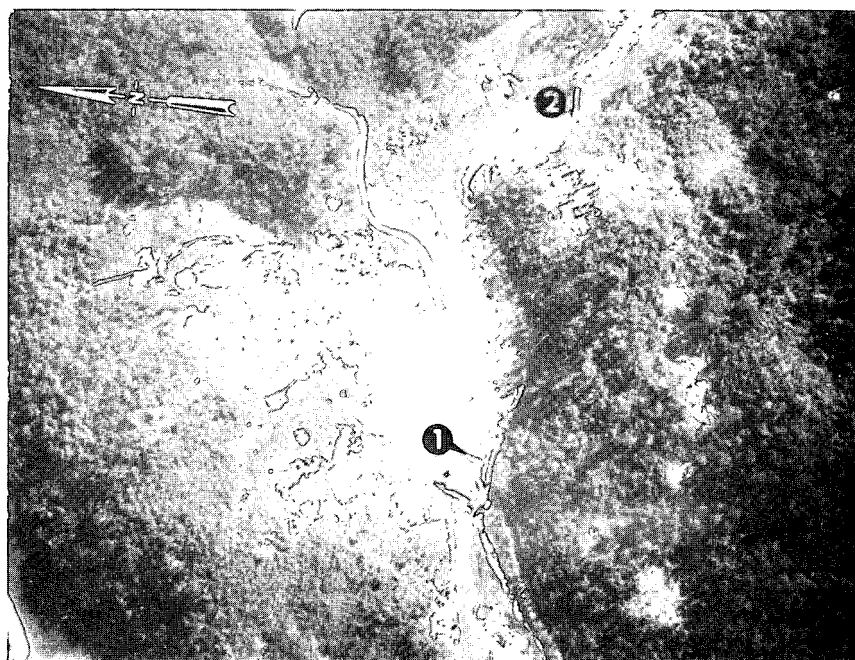
25X1 STATUS: No change [REDACTED]

25X1 By-Pass No. 1 - constructed 70' x 10' (approx.) ford; probable rock/gravel base; 40' E of main bridge; serviceable.

25X1 By-Pass No. 2 - 3-span [REDACTED] (approx.) wood, deck-type bridge with 15' spans, 780' E of main bridge; serviceable.

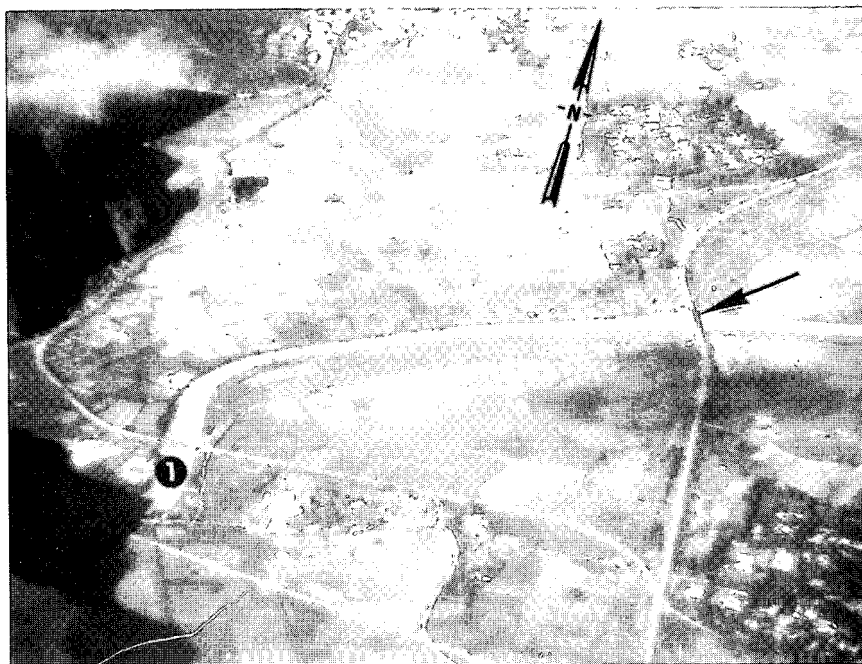
25X1 STATUS: No change [REDACTED]

25X1 COMPENSATIVE ACTION:  
By-Pass No. 1 [REDACTED] probable 4-span [REDACTED] (approx.) steel 25X1  
and timber deck-beam bridge with spans measuring [REDACTED] approx.;  
1800' W of main bridge; repaired and serviceable. 25X1

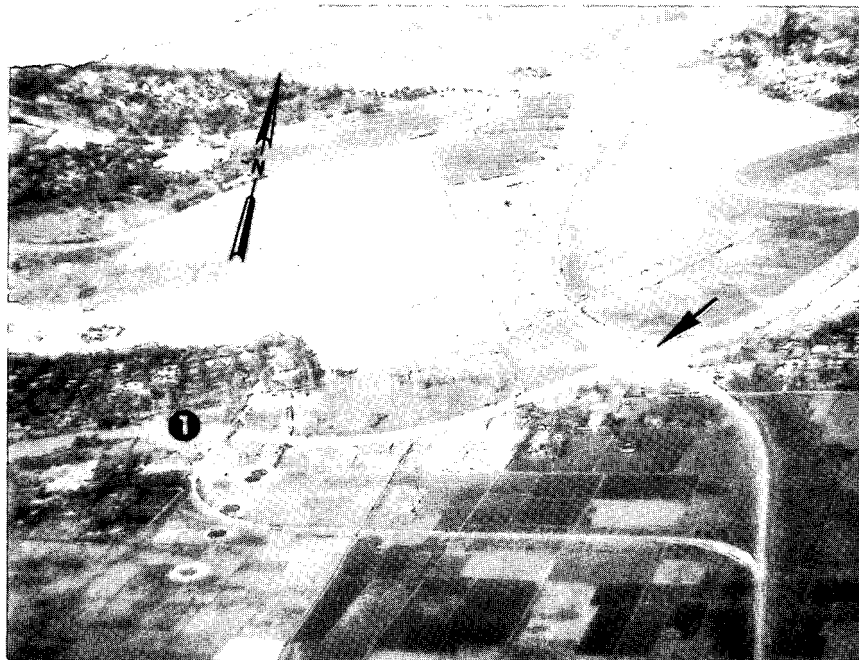
25X1 Original destroyed bridge replaced by a 4-span, steel and timber deck-beam bridge  approx.; with spans measuring 25'; serviceable.

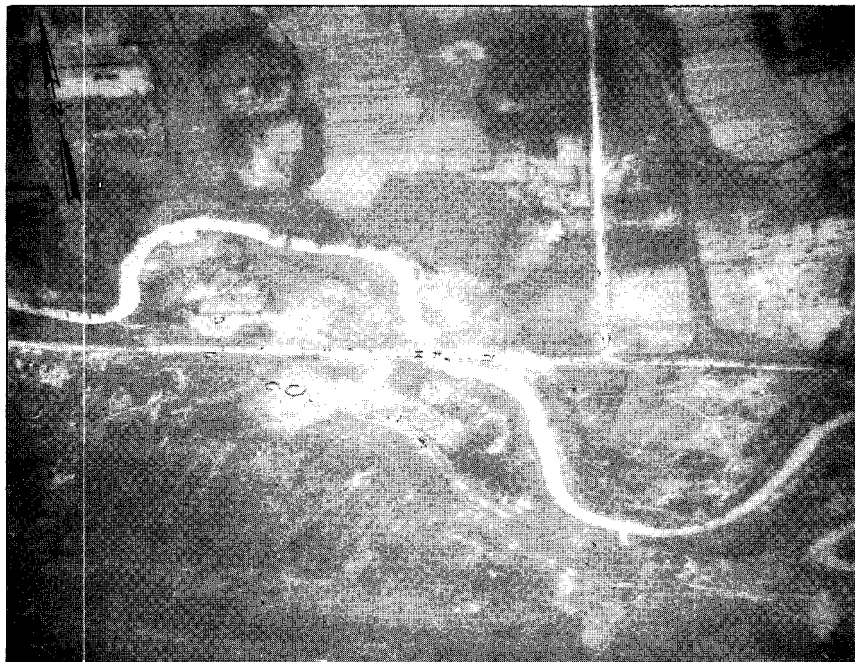
STATUS: Original bridge has been destroyed and is replaced by a 14 span, deck-beam bridge measuring 230' x 5' approx. supported by A-frames and cables. The rail line does not connect with the segment of track over the bridge, suggesting that the bridge is used only to shuttle material over the river.

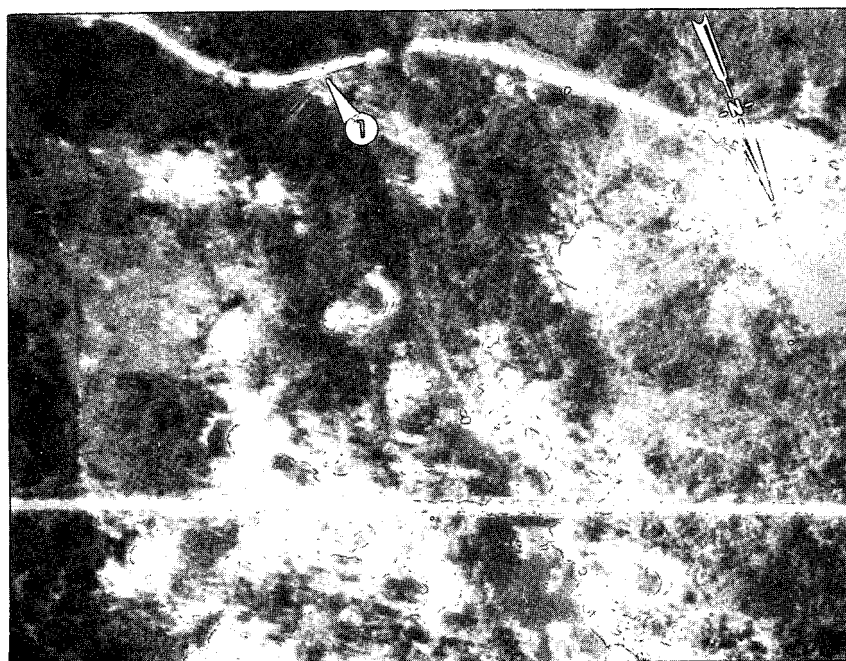
By-Pass No. 1 - 3-span  (approx.) timber deck bridge with 15' spans;  
 280' S of main bridge; serviceable to vehicles only.

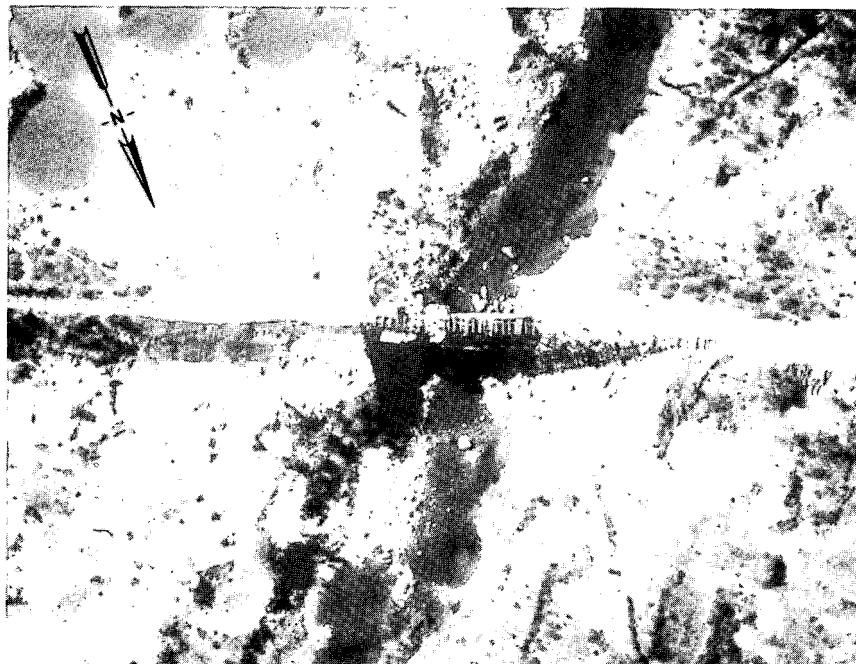
25X1 By-Pass No. 1 - constructed [REDACTED] (approx.) ford; probable rock/gravel base; 600' NE of main bridge; serviceable to vehicle traffic only.

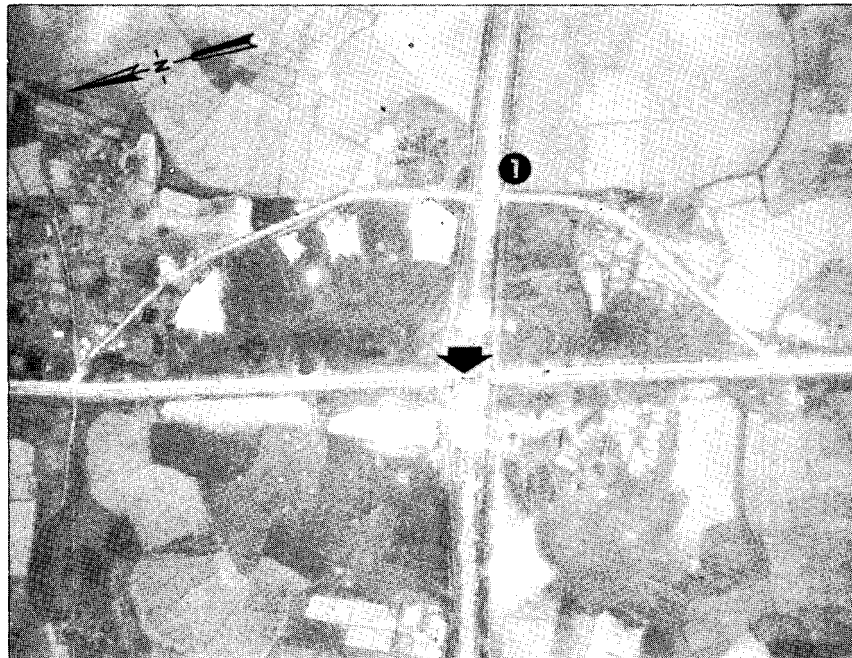
Serviceable - possibly repaired using rock fill to form a causeway.

By-Pass No. 1 -  +span  (approx.) timber deck type bridge with 15' spans; approx. 300' E of main bridge; possibly serviceable.

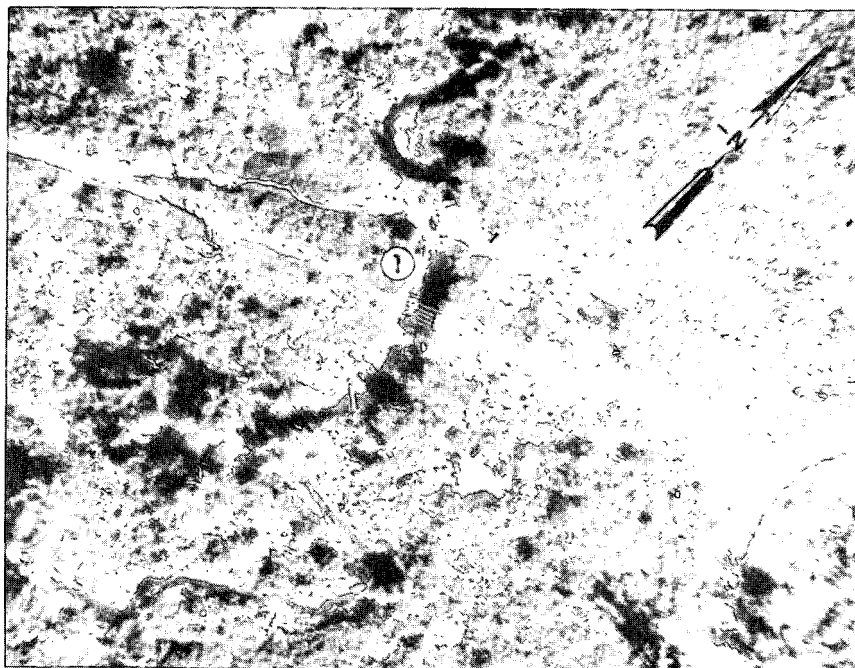
New probable beams have been laid on the old abutments. No sign of removeable decking has been noted; approaches appear unused.

By-Pass No. 1 - constructed   ford/causeway; probable rock/gravel base; 40' N of main bridge; overgrown - used for foot traffic only.

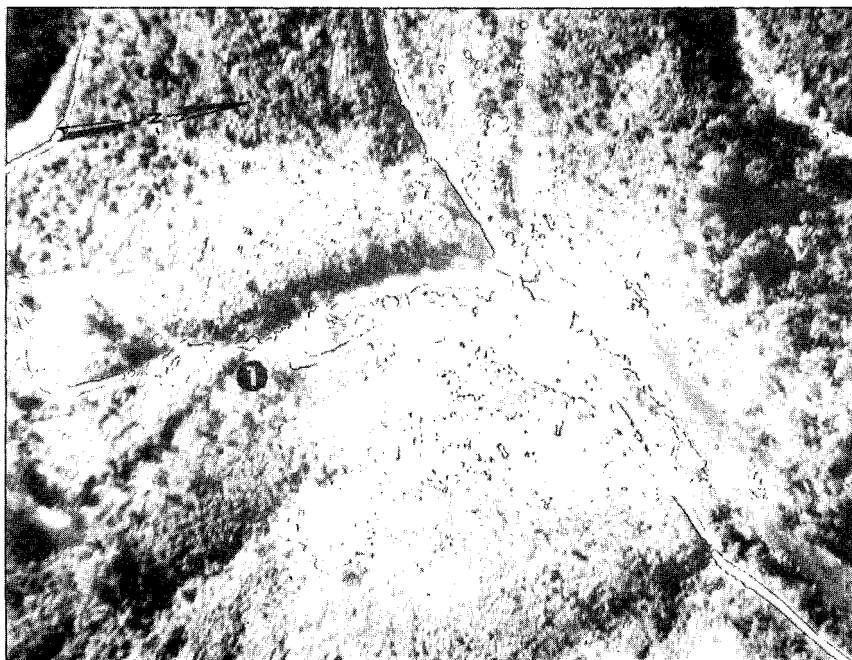
STATUS: 1 abutment slightly damaged; bridge repaired and serviceable.

By-Pass No. 1 - constructed 90' x 15' (approx.) ford; probable rock/gravel base; 530' S of main bridge; serviceable.

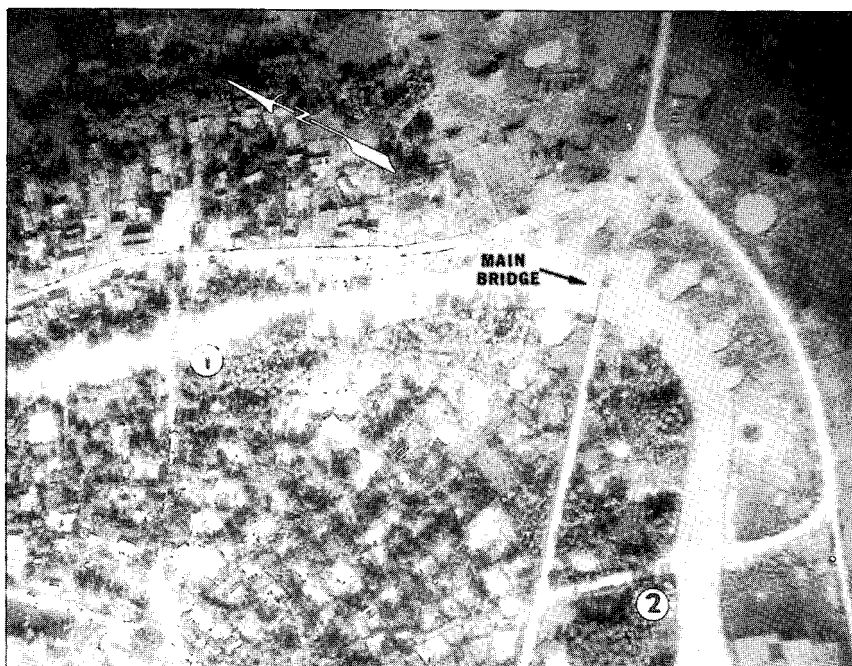
2 spans dropped; 2 spans lightly damaged; 1 abutment severely damaged;  
1 bent severely damaged.

By-Pass No. 1 - 6-span, [redacted] (approx.), wood and steel deck-beam bridge, with spans measuring 1 @ 25' and 5 @ 15' (approx.); 850' NW of main bridge; under construction, possibly serviceable to light vehicle traffic.  
By-Pass No. 2 - ferry landings located 550' S of main bridge; serviceable; no ferry boats noted.

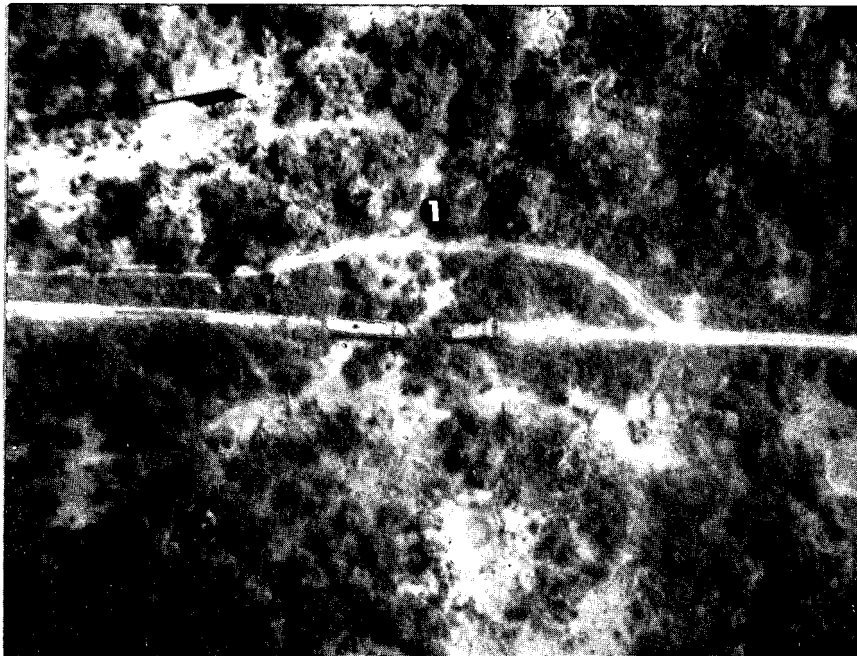
3 spans destroyed; 2 spans severely damaged.

By-Pass No. 1 - natural  (approx.) ford; 50' E of main bridge; serviceable.

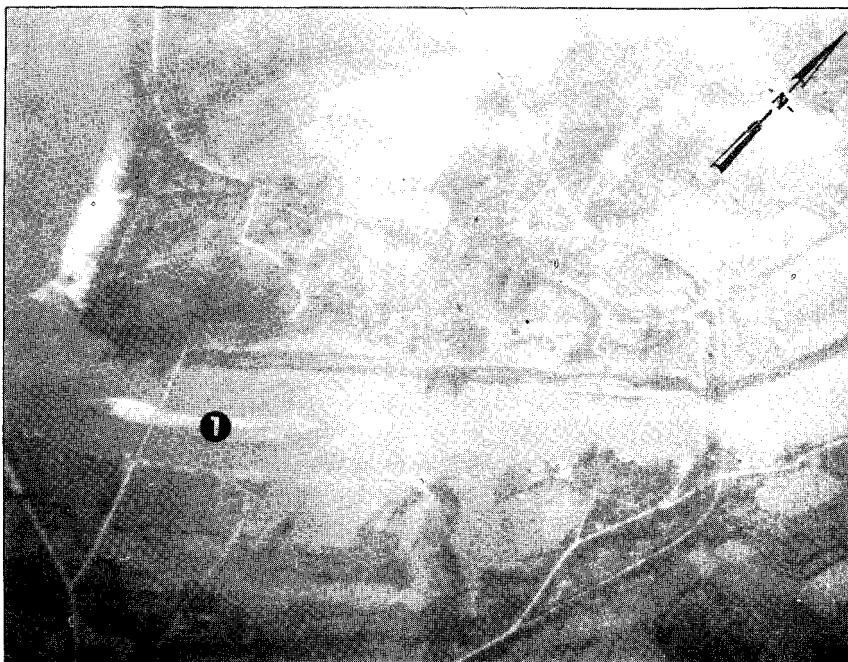
STATUS: 4 spans and 3 piers destroyed; abutments intact.

25X1 COMPENSATIVE ACTION: By-Pass No. 1 [redacted] (approx.) wood deck highway pontoon bridge; 0.7 nm SW of main bridge; serviceable.

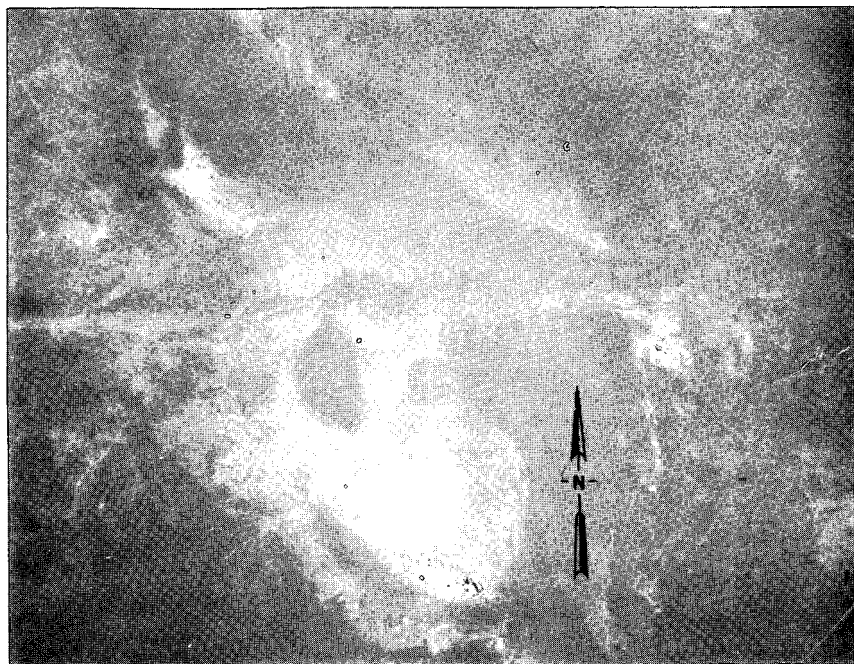
STATUS:  
3 spans dropped; 2 spans slightly damaged.

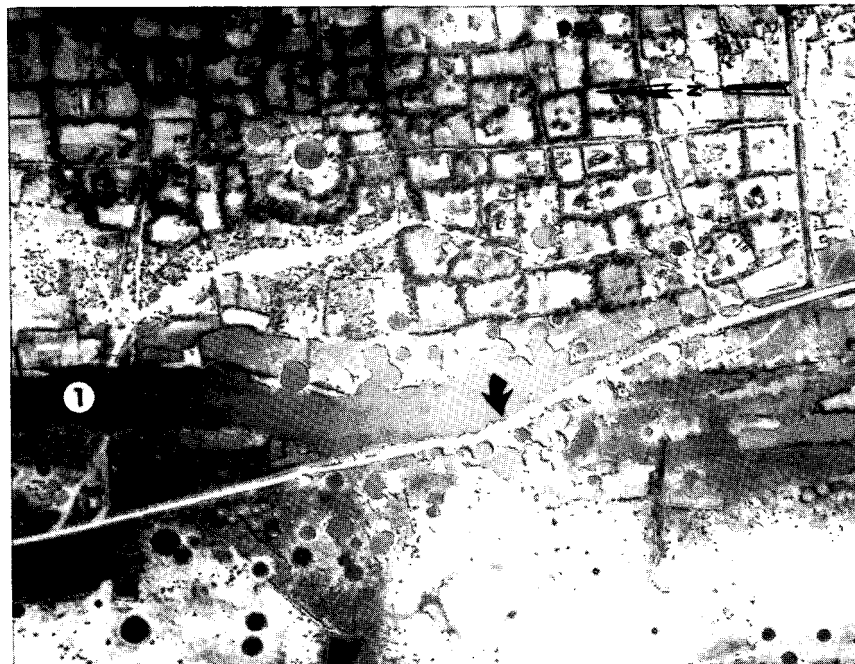
Completely destroyed and replaced by a rock fill causeway.

By-Pass No. 1 - constructed 130' x 10' (approx.) ford; probable rock/gravel base; 7500' N of main bridge site; serviceable.

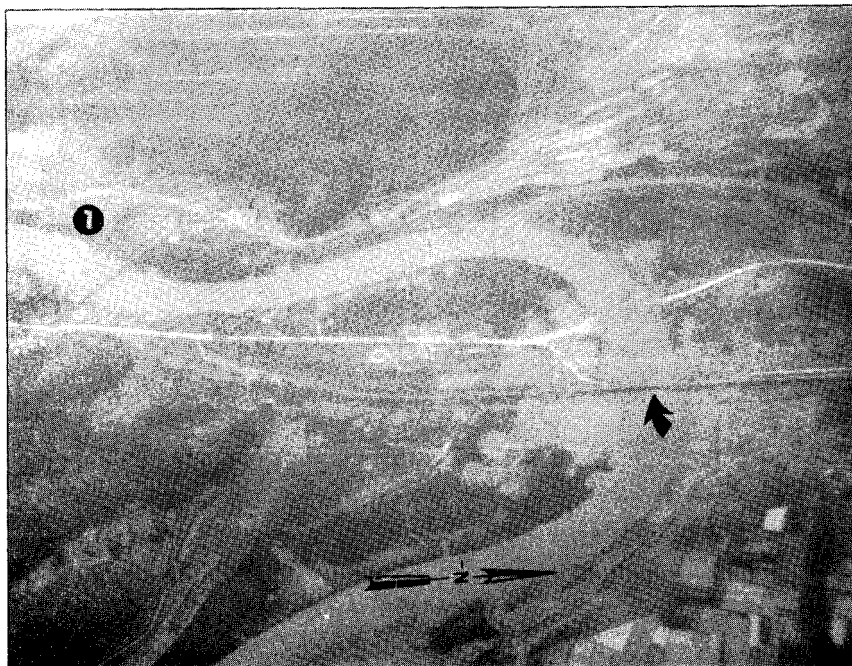
STATUS: 4 spans probably destroyed; 1 pier probably damaged.

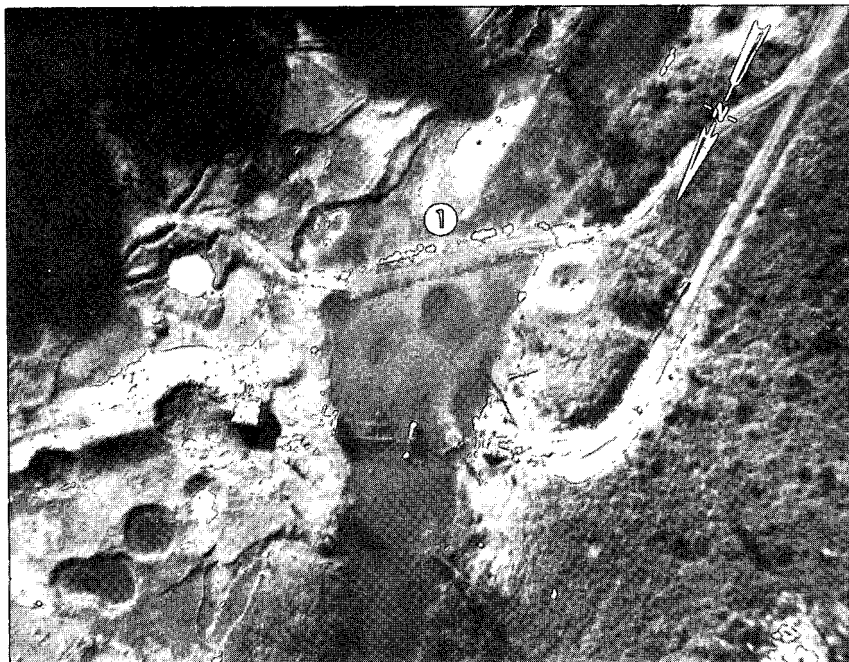
3 spans destroyed; 1 abutment severely damaged; 1 abutment lightly damaged;  
bridge probably under repair using cables with removeable wood decking.

By-Pass No. 1 - [REDACTED] constructed [REDACTED] (approx.) ford;  
probable rock/gravel base; 120' S of main bridge; serviceable.

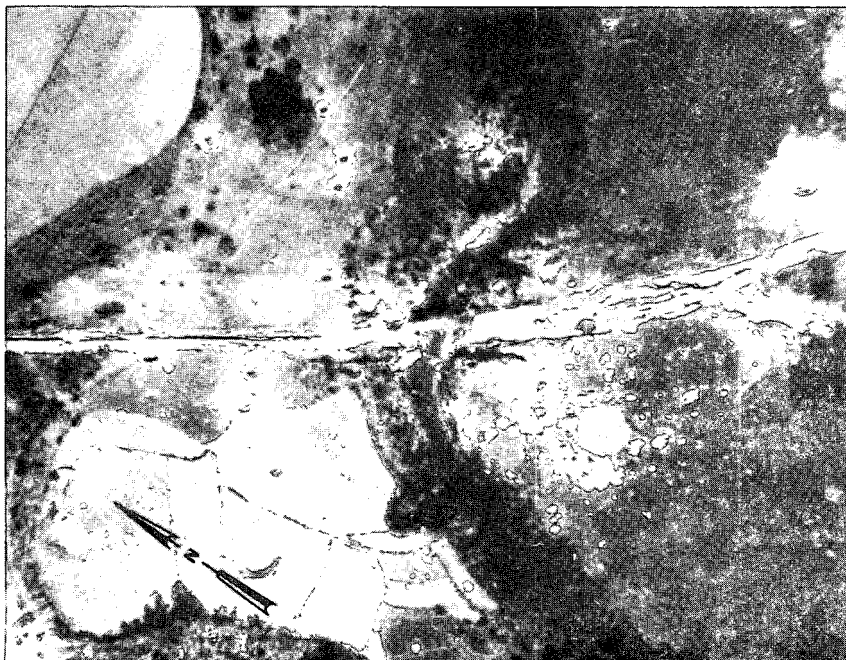
STATUS: 1 span destroyed; 1 span severely damaged; 1 abutment destroyed.

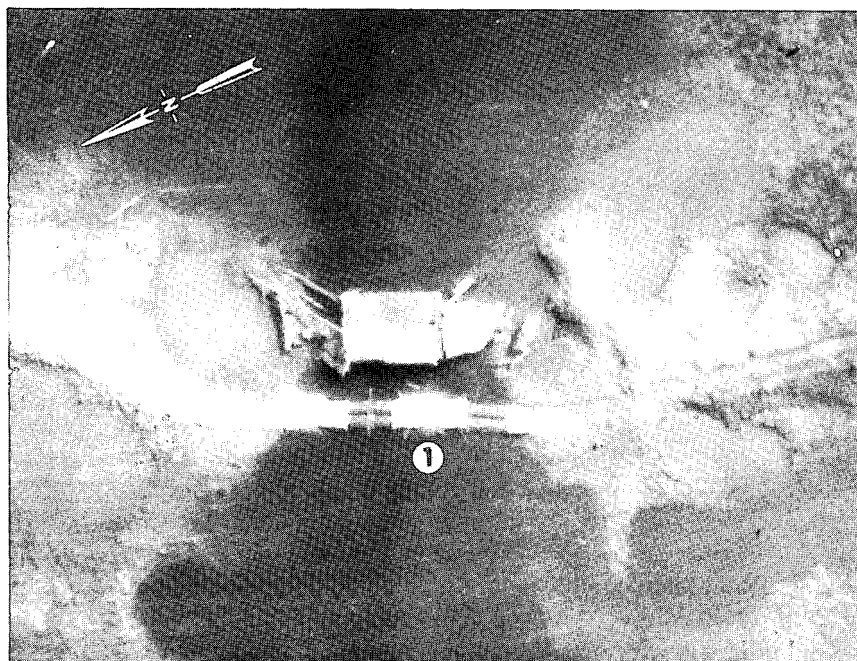
STATUS: 2 spans dropped; 1 abutment destroyed; 1 abutment damaged; 1 span damaged.

By-Pass No. 1 - 3-span [REDACTED] timber and possible steel deck-type bridge  
with spans measuring [REDACTED] and a [REDACTED] probable  
rock fill causeway in the center; adjacent to the main bridge  
on NW side; serviceable.

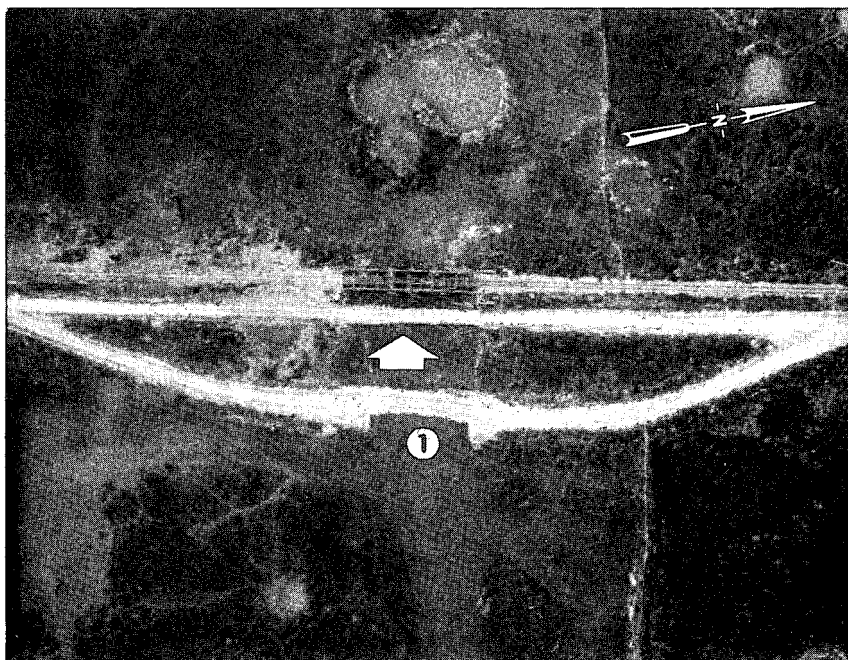
1 abutment destroyed; 1 span destroyed; bridge has been repaired and is serviceable.

By-Pass No. 1 - 2 (probable) span 60' x 10' wood deck-type highway bridge with spans measuring 30'; 40' E of main bridge; serviceable.

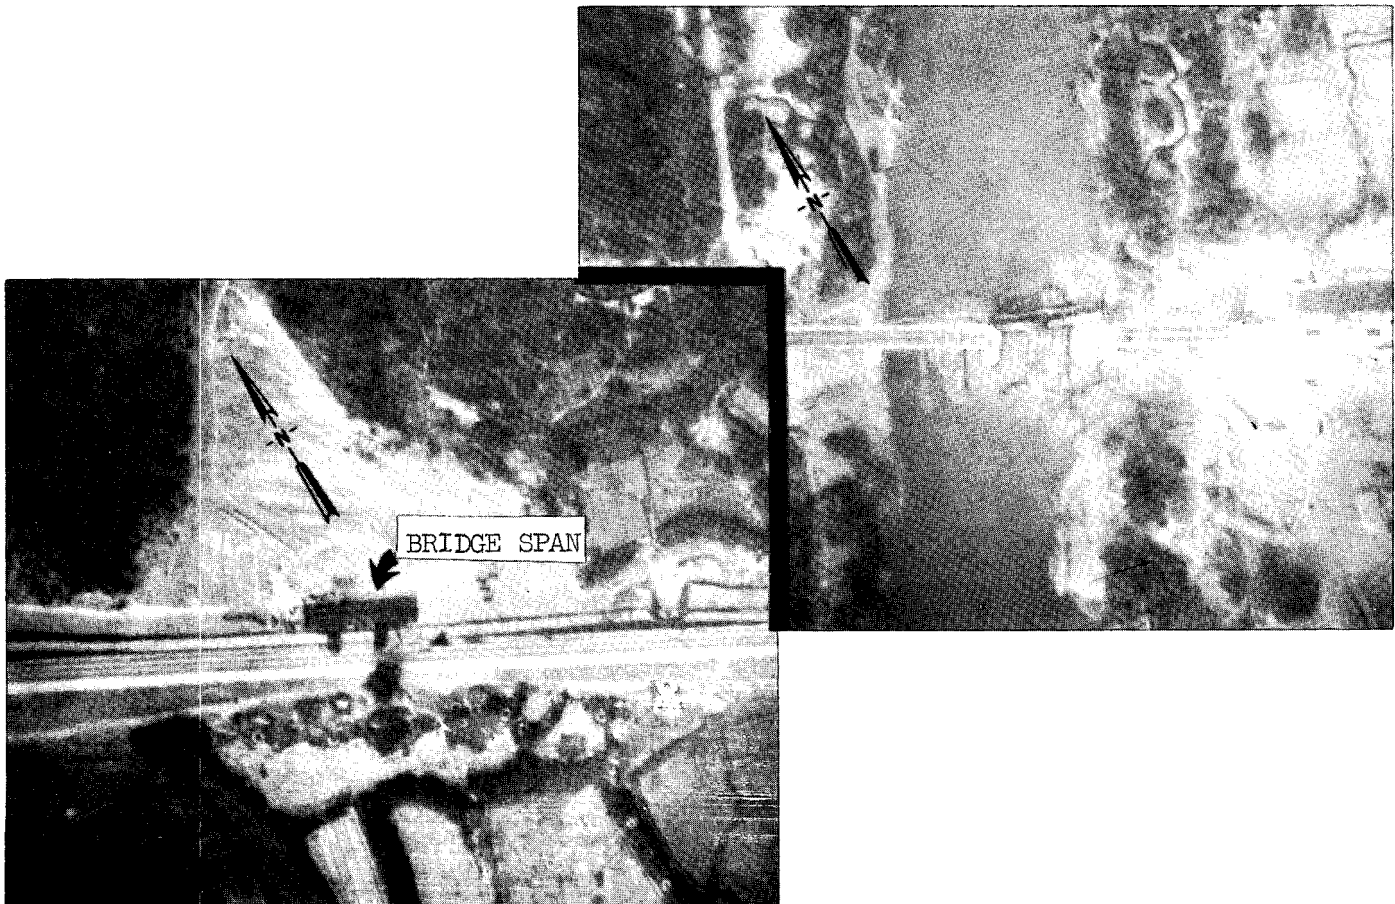
Probable replacement span under construction 1450' NW of the bridge.  
 Large quantity of construction material is located between the replacement span and the bridge.

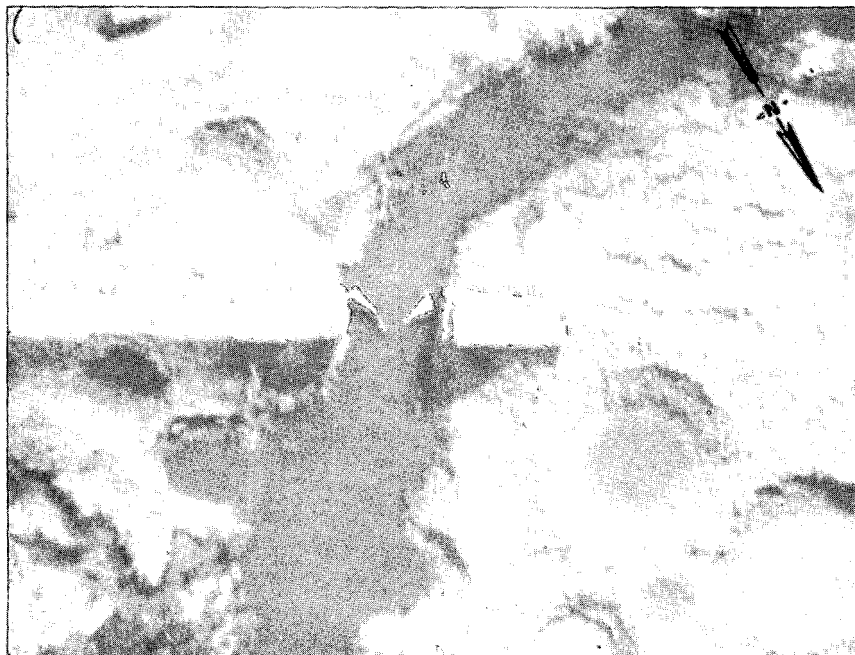
Replacement cable bridge unserviceable; cables have apparently been removed; no new bomb damage observed.

- By-Pass No. 1 - ferry landings 100' W of main bridge; serviceable; no ferryboats noted.
- By-Pass No. 2 - ferry landings 360' NW of main bridge; serviceable; no ferryboats noted.
- By-Pass No. 3 - ferry landings 500' NW of main bridge; serviceable; no ferryboats noted.
